UNDERWATER BRIDGE INSPECTION REPORT

STRUCTURE NO. 27611

PLYMOUTH AVENUE

MISSISSIPPI RIVER

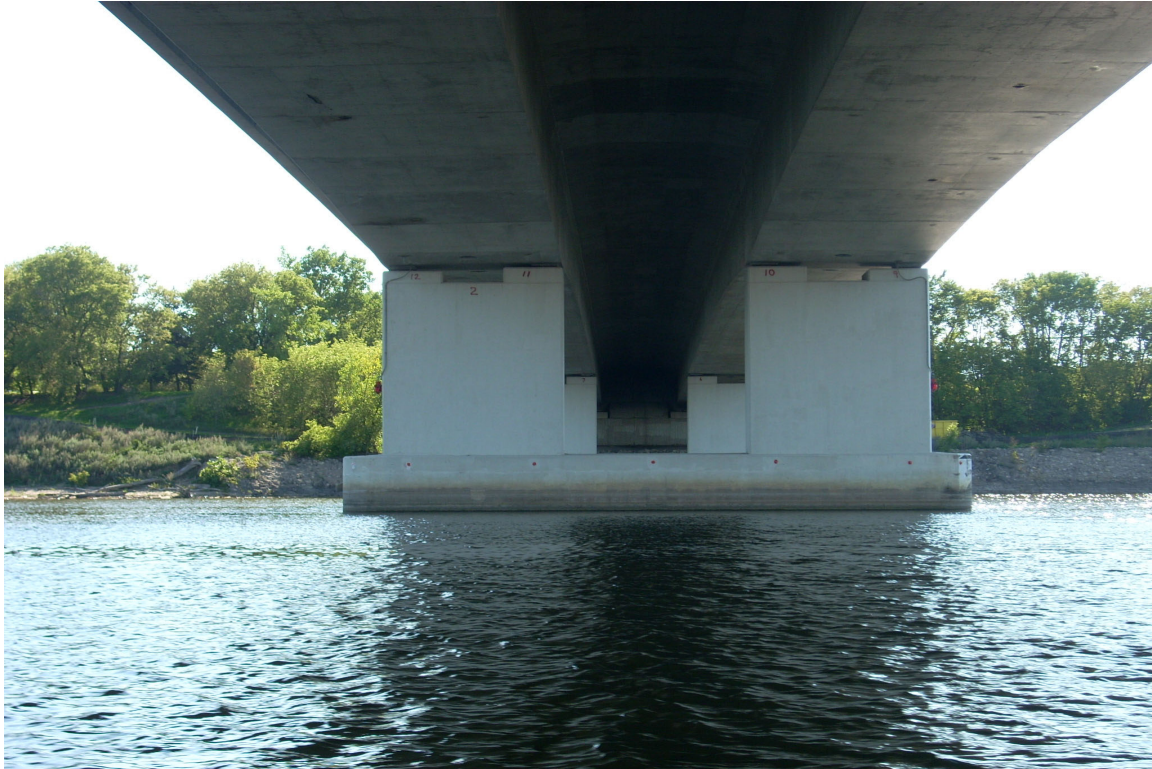
Photograph 3. View of Pier 2, Looking West.

- A vertical hairline crack was observed from the top of the web wall to the waterline.
- A scour depression was observed from the upstream nose to the downstream nose and all along the west face of the pier. The scour had a radius of about 10 feet and a maximum depth of 3 feet. The scour had exposed the pier footing at the upstream nose and for 30 feet along the west face of the pier with no vertical face exposure.

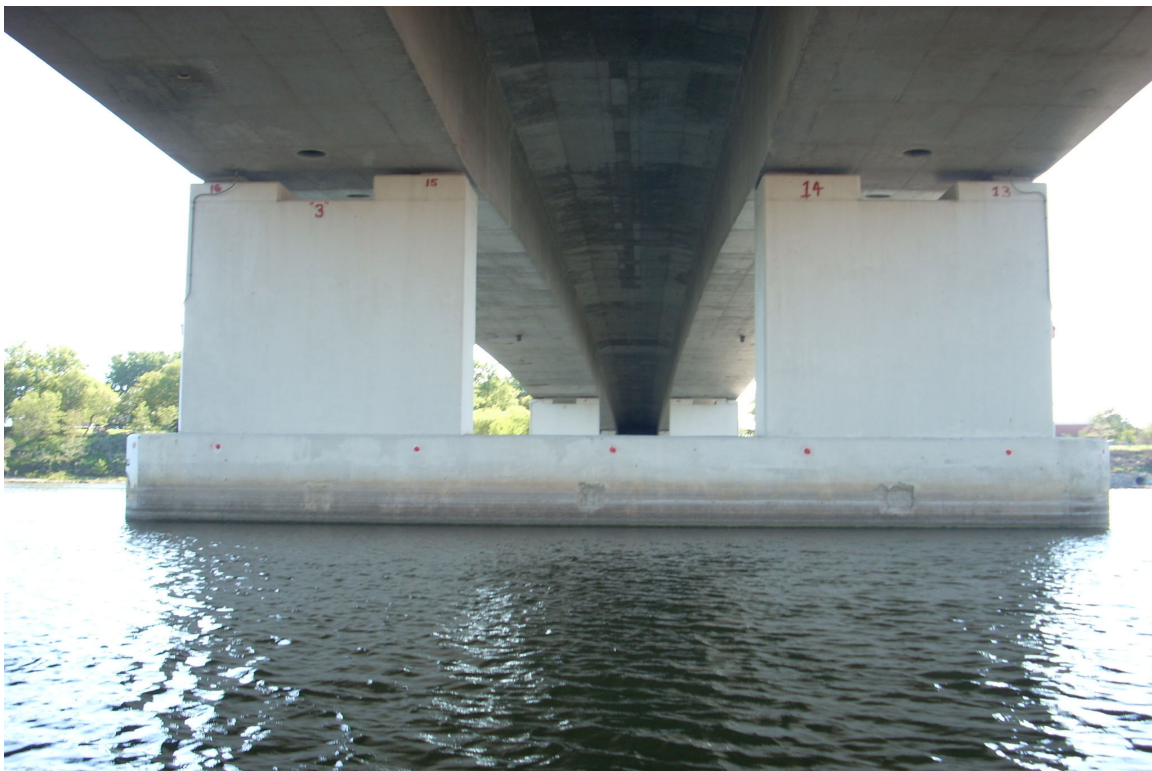
Photograph 4. View of Pier 3, Looking West.

- A scour depression with an 6 foot radius was observed with a maximum depth of 1.5 feet at the upstream nose of Pier 3.
- At 2 feet above waterline, at midpoint and both quarter points of east face of Pier 3 there is a 1 square foot area of section loss with 2 inches maximum penetration.

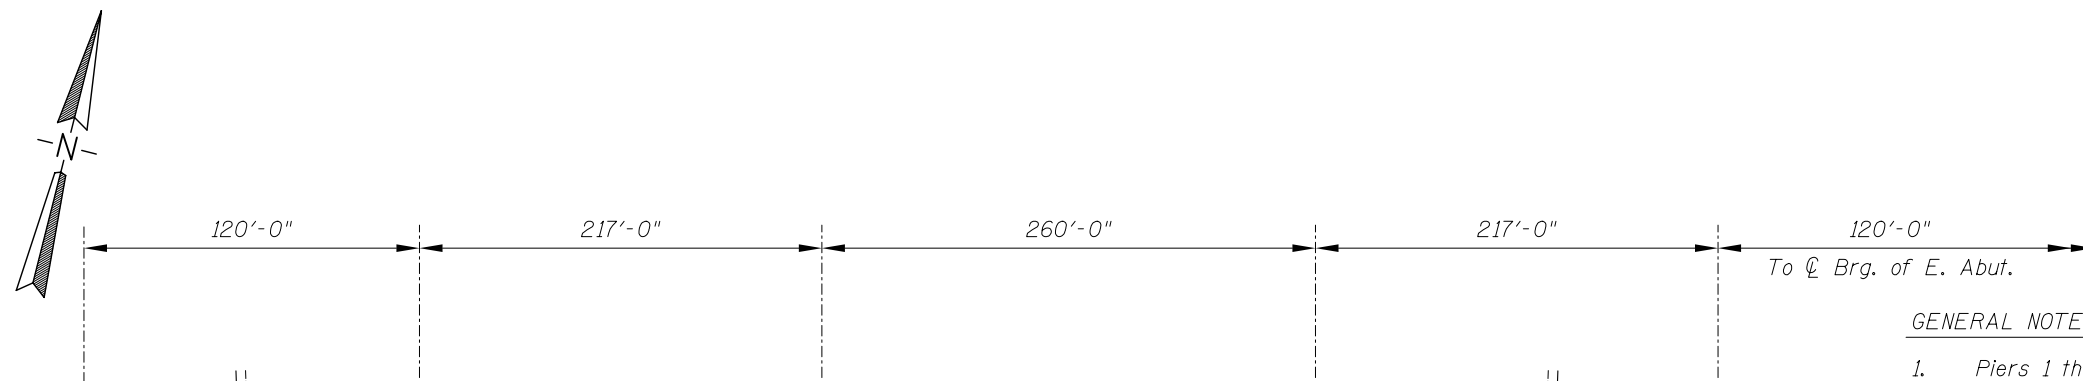
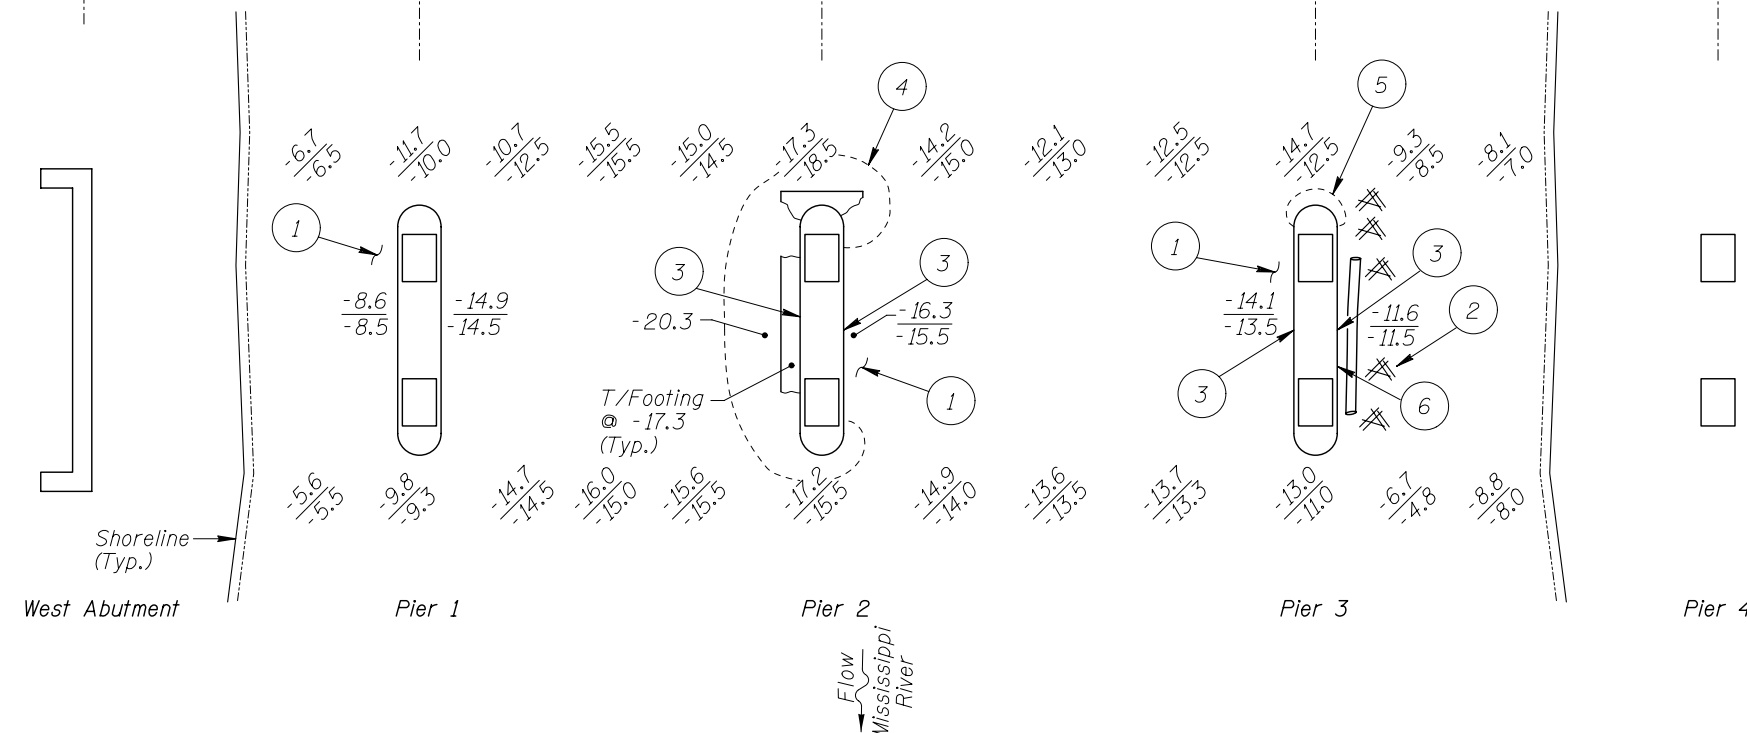
INSPECTION AND SOUNDING PLAN

- The channel bottom material consisted of silty sand and gravel with up to 8 inches of probe rod penetration.
- A light accumulation of timber debris was observed along the east face of Pier 3 from channel bottom up 3 feet. The debris consisted of a 2 foot diameter log and random 6 to 12 inch diameter debris.

- (A) Monitor the footing exposure and scour at Pier 2 and local scour at Pier 3, and if found to be increasing in the future, countermeasures may become warranted based on the findings of the scour analysis/rating done in 1996.
- (B) Reinspect the submerged substructure units at the normal maximum recommended (NBIS) interval of five (5) years.
